# Lighthouse, Joensuu, Finland: Thread Bars in a Discontinuous Post-Tension System

**CTBUH 2022  
Steel-Timber Conference**

# Lighthouse Joensuu

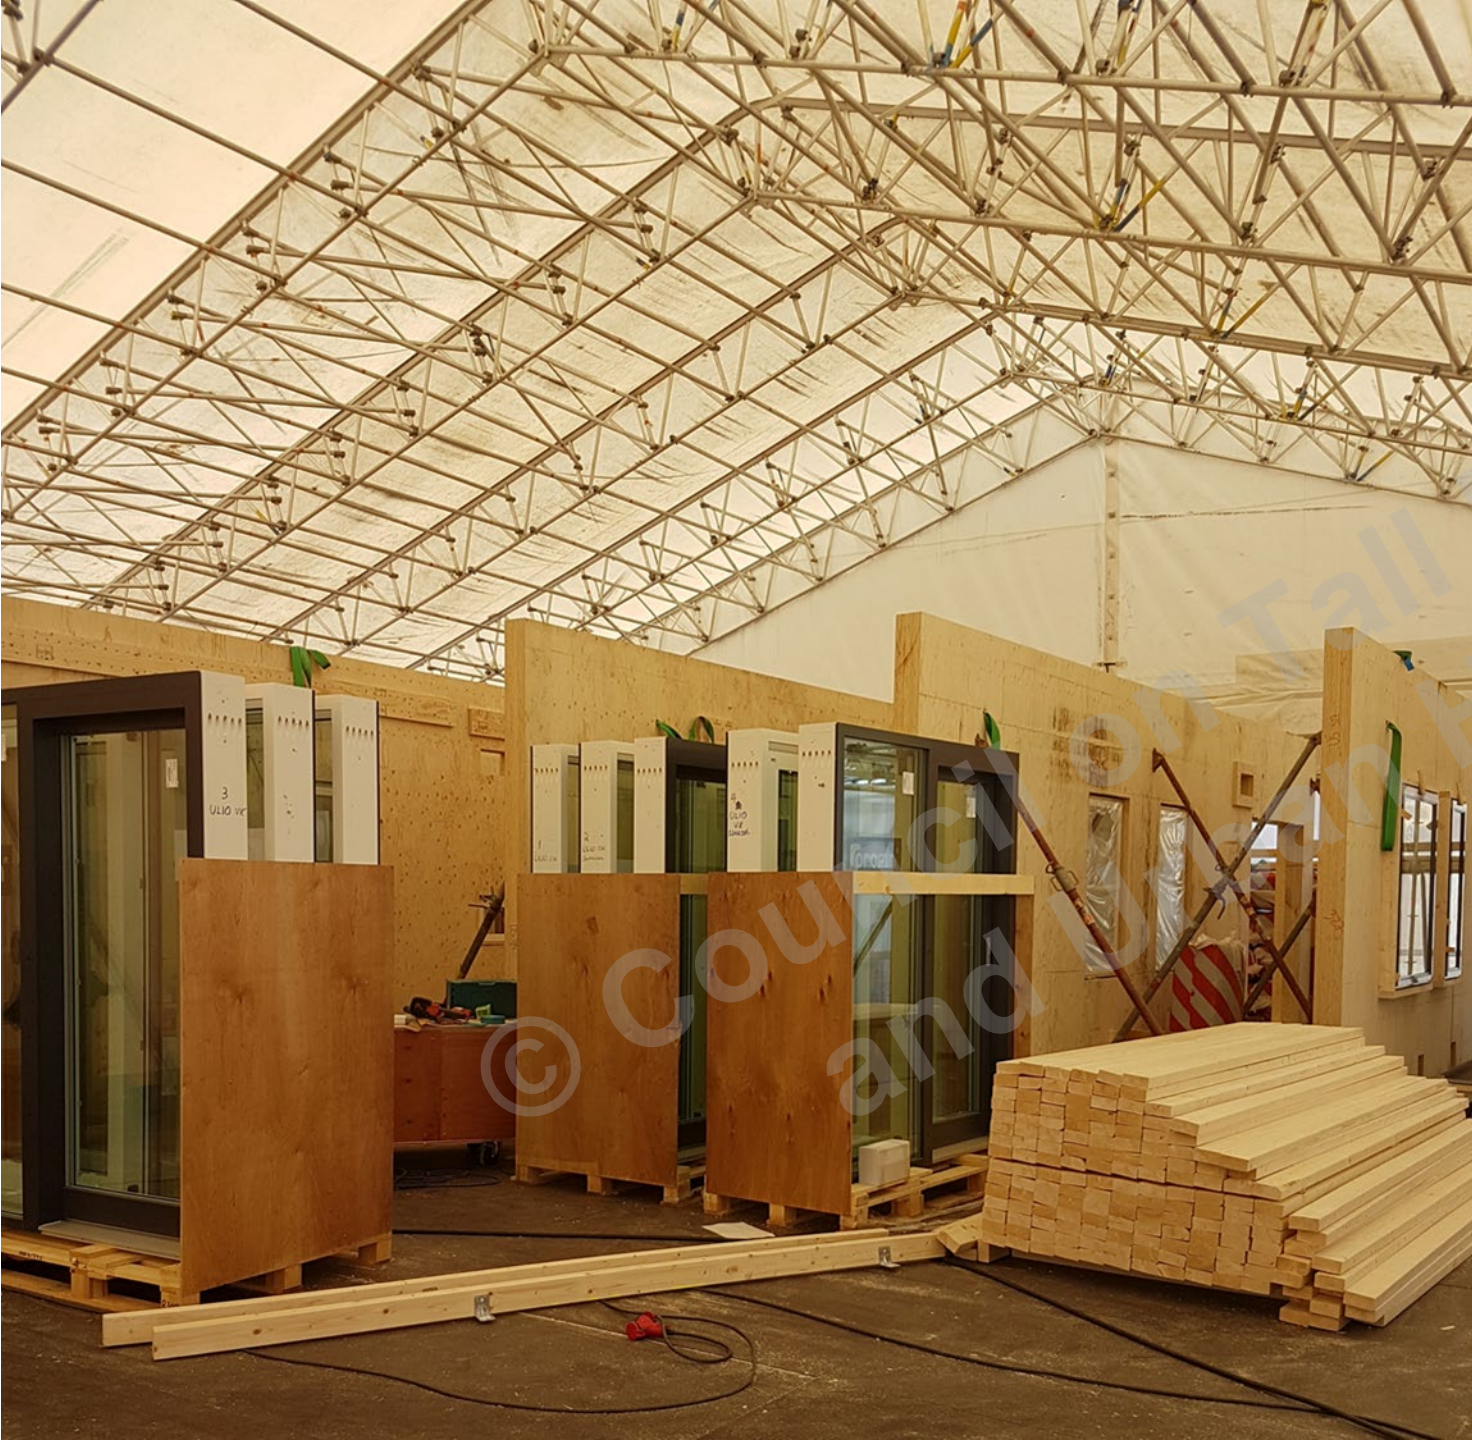
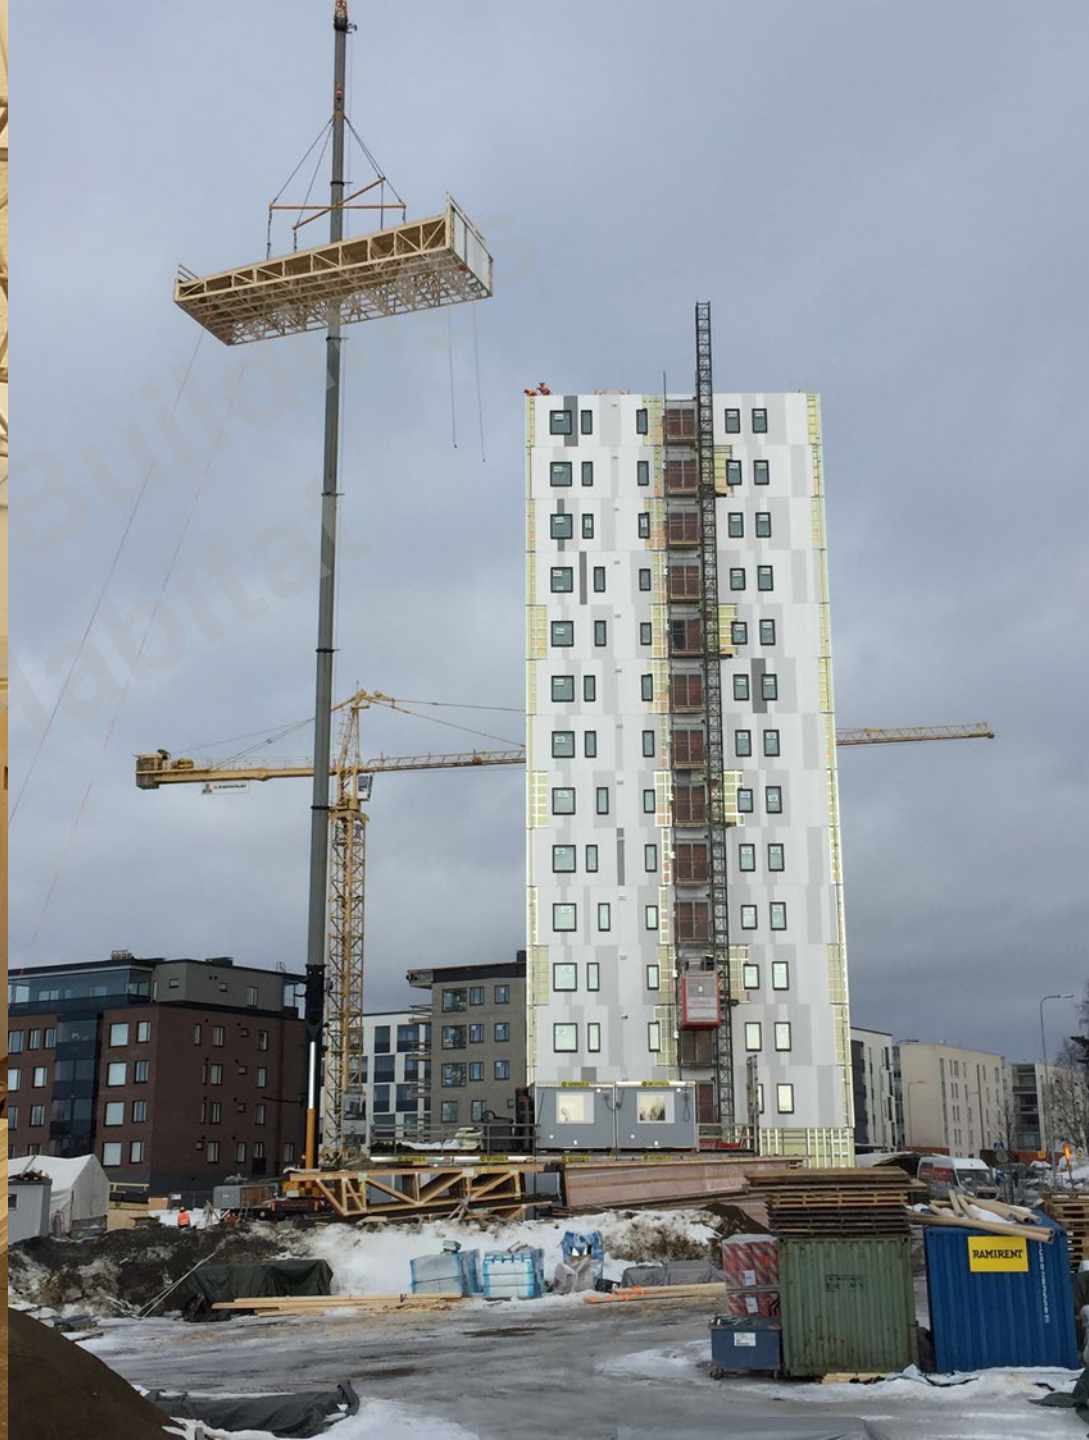
- Located in Joensuu, Finland
- Housing for students
- 117 residences
- 14-storeys
- Total height of 48 meters (157.5 ft)
- Completed 2019

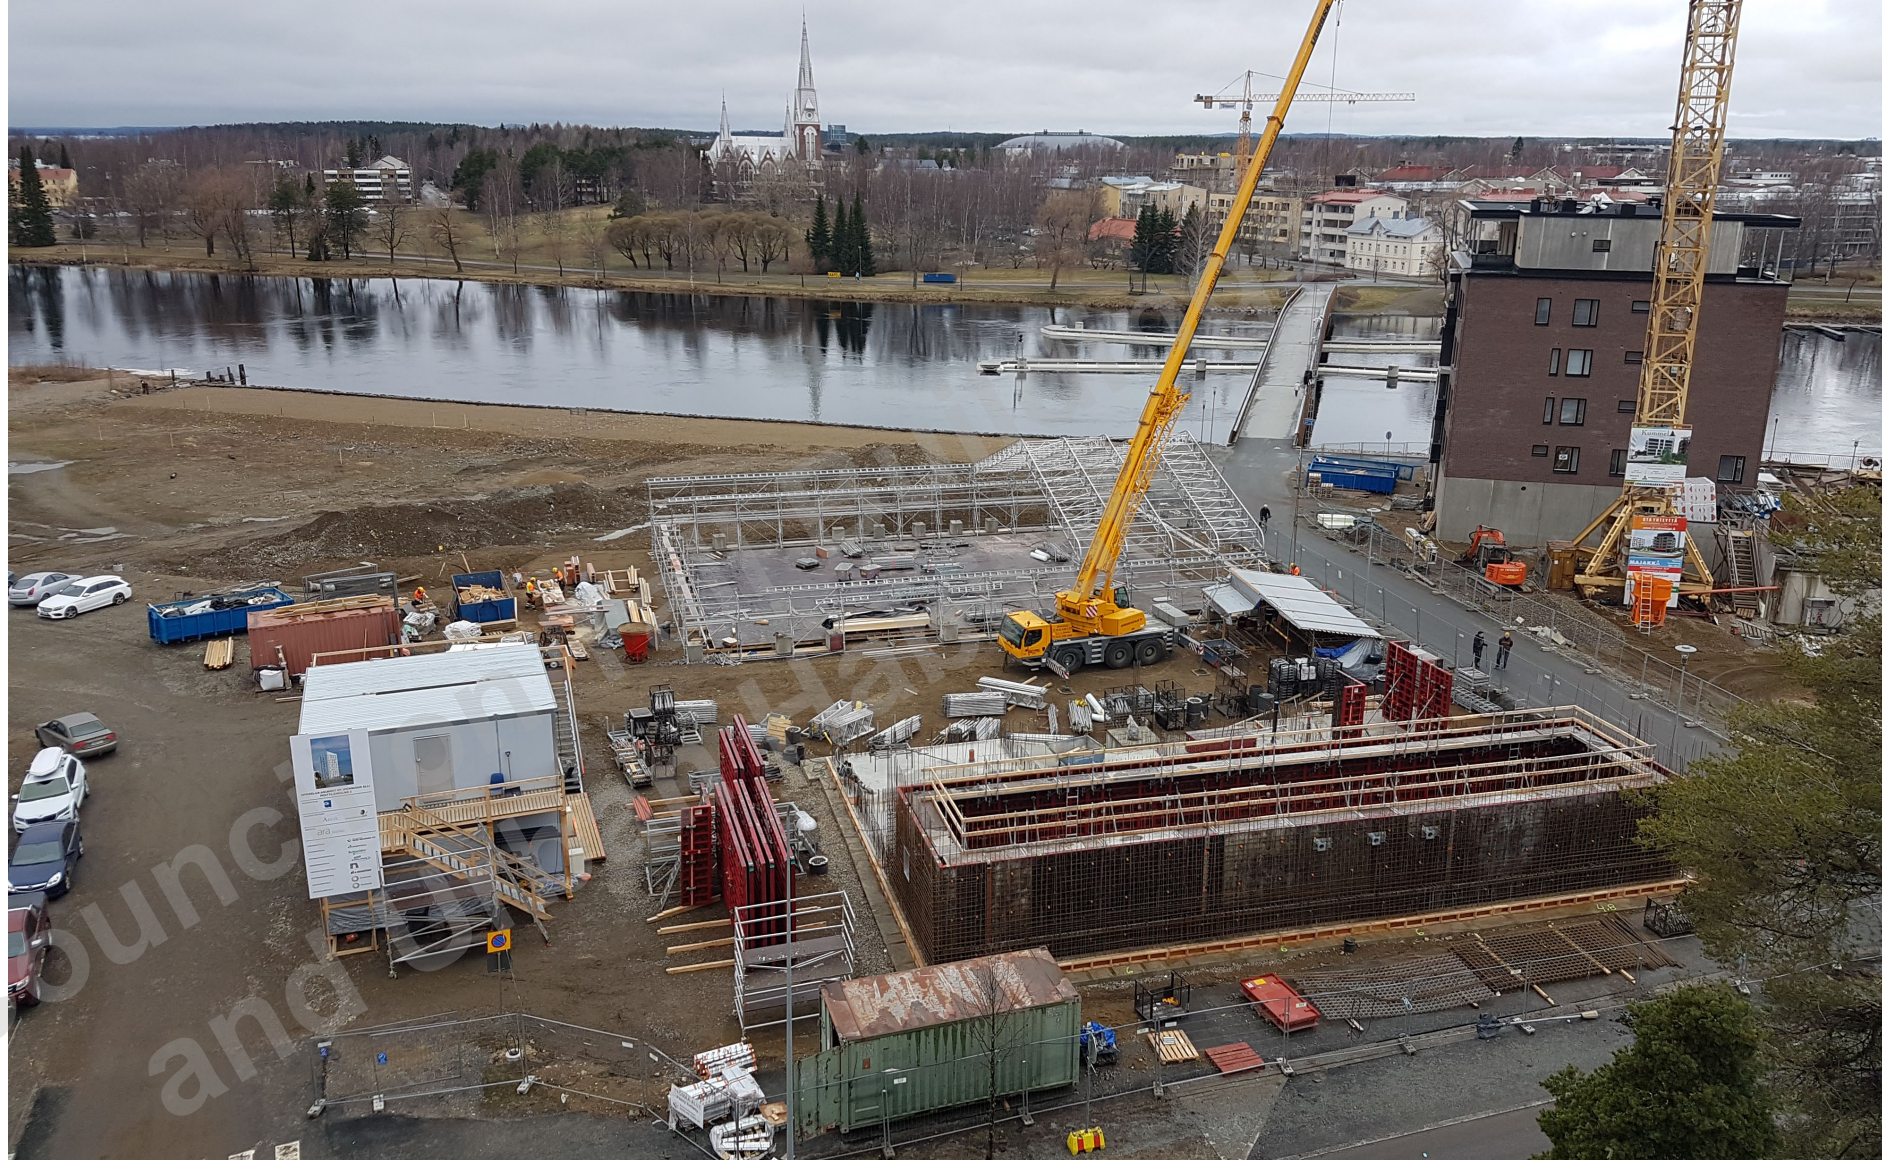
# Structural facts

- Mass-timber frame
- Shear wall system
- Pile foundations
- Podium slab
- High strength steel rods
- Rothoblaas connectors

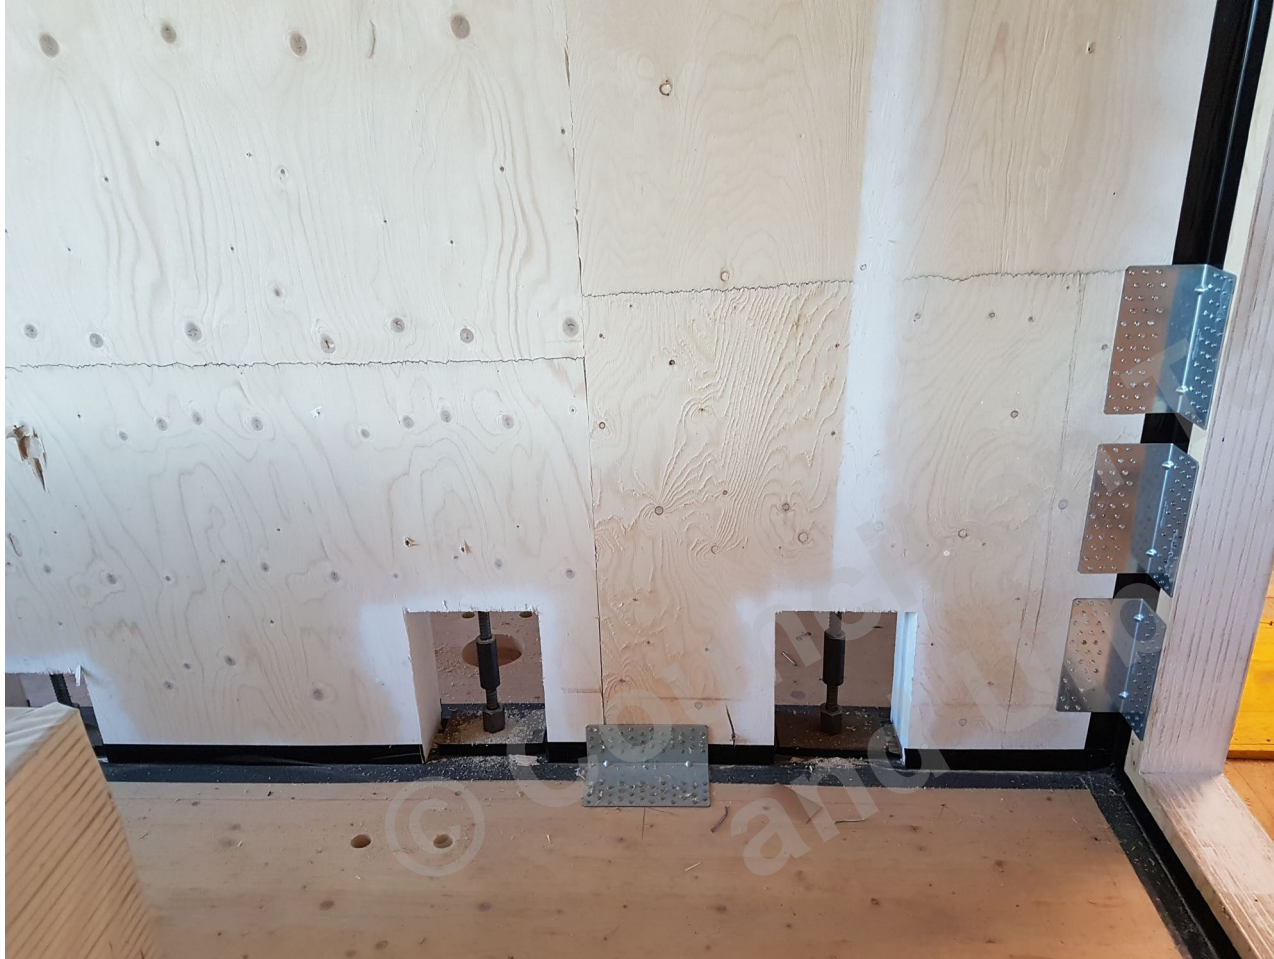
# Use of tension rods

# Tension rods

- Main stability against overturning forces by using post tensioned rods
- Internal and unponded
- SAS 670/800
